# Vista View & Vista View ™ Plus

## **Troubleshoot Manual**

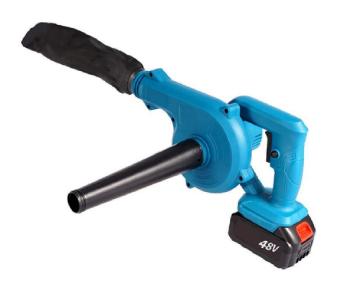
### 1. Dirt and Debris

**Tracks** are prone to collecting dirt and debris if not maintained. This may be the culprit of multiple problems listed below.

Clean **tracks** with a brush, vacuum, and microfibre cloth. The inside of the **housing** may require exposing and cleaning at the bottom.

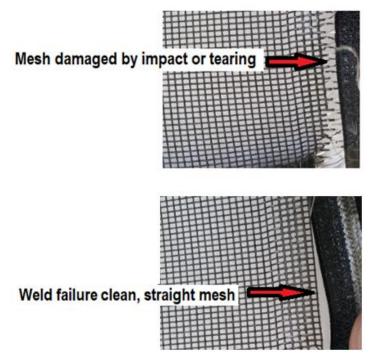
### 11. "Mesh is damaged"

A rescreen is required. See the "Service & Maintenance Guide" via wizardscreens.com/installation.

You can attempt to repair an impact tear by using **fabric glue** and a **black sharpie**.
